## **Safer Alternatives to Current Floor Wax Strippers for Schools and Public Buildings**

Katy Wolf

Institute for Research and Technical Assistance

October 2015

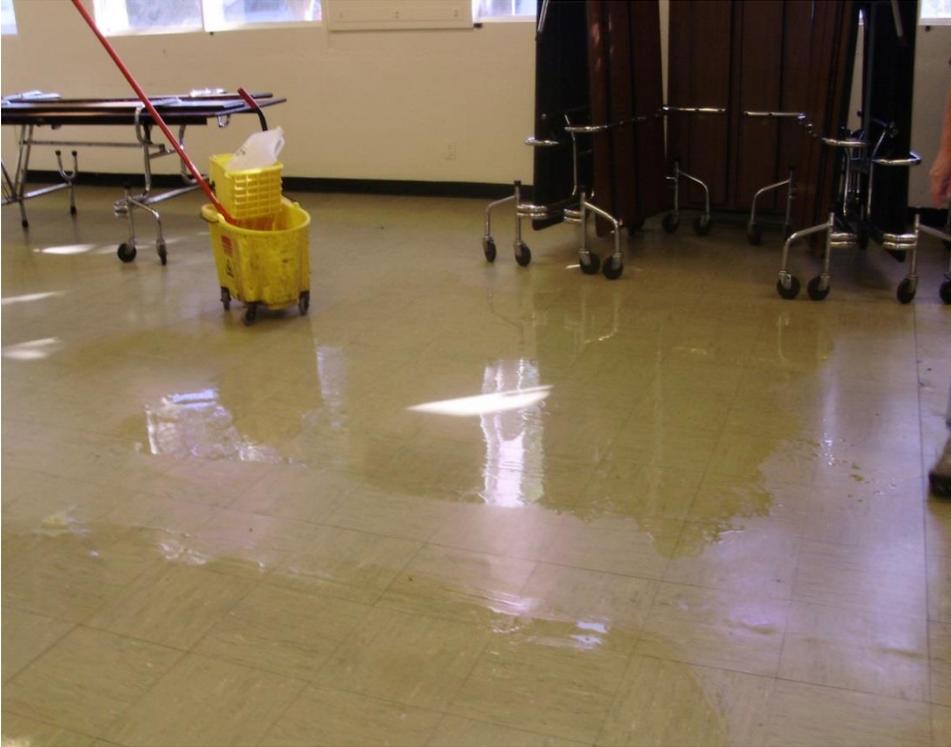
Figure 2-1. Stripper Applied to Floor

The maintenance staff strips the wax from the floor, rinses it and reapplies wax every seven months. It requires three workers for four hours each (12 person hours) to strip 1,000 square feet of VCT. The stripper is first diluted to the proper concentration which is often about four parts water to one part stripper. The stripper is applied to the floor with a mop and is allowed to work for five to 15 minutes. The stripper needs to penetrate the wax layers and, in some cases, there is a significant buildup. When the stripper begins to work, it bubbles up on the floor. A picture of the floor with the stripper applied is shown in Figure 2-1. A floor machine with an abrasive pad is then moved over the floor area to be stripped; it uses a rotary movement of the pad to accomplish the stripping. A picture of the floor machine stripping the floor is shown in Figure 2-2. The residue of the wax and stripper is sucked up with a wet vacuum. This process is shown in Figure 2-3. Finally, rinsewater is applied to the floor with a mop and the residue is again sucked up in the vacuum. The residue of the wax, stripper and rinsewater is put in a bucket and flushed to the sewer.

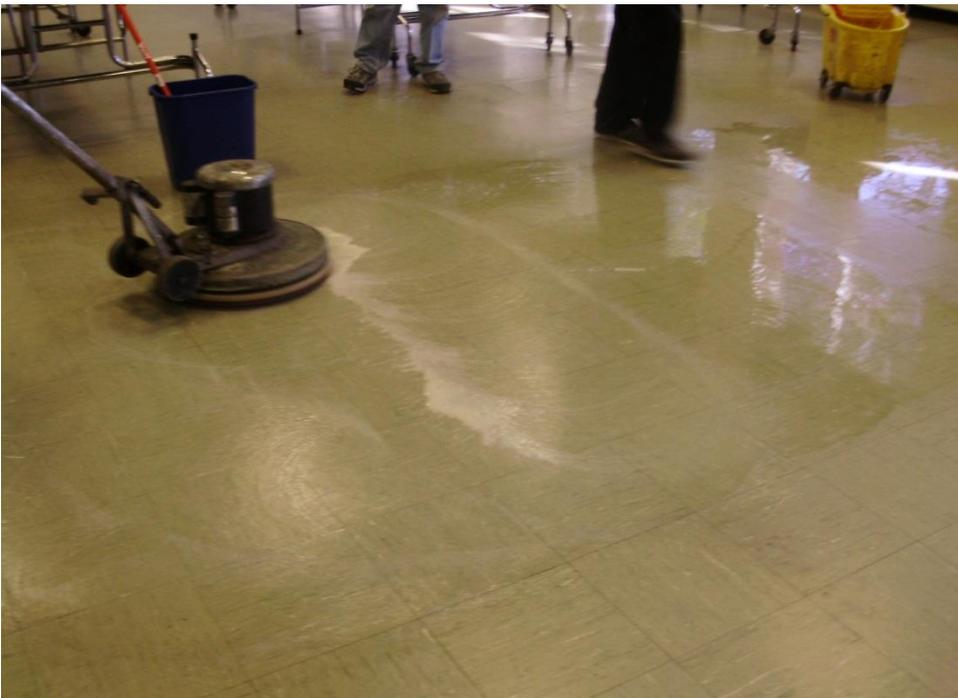
Figure 2-2. Floor Machine Stripping Wax

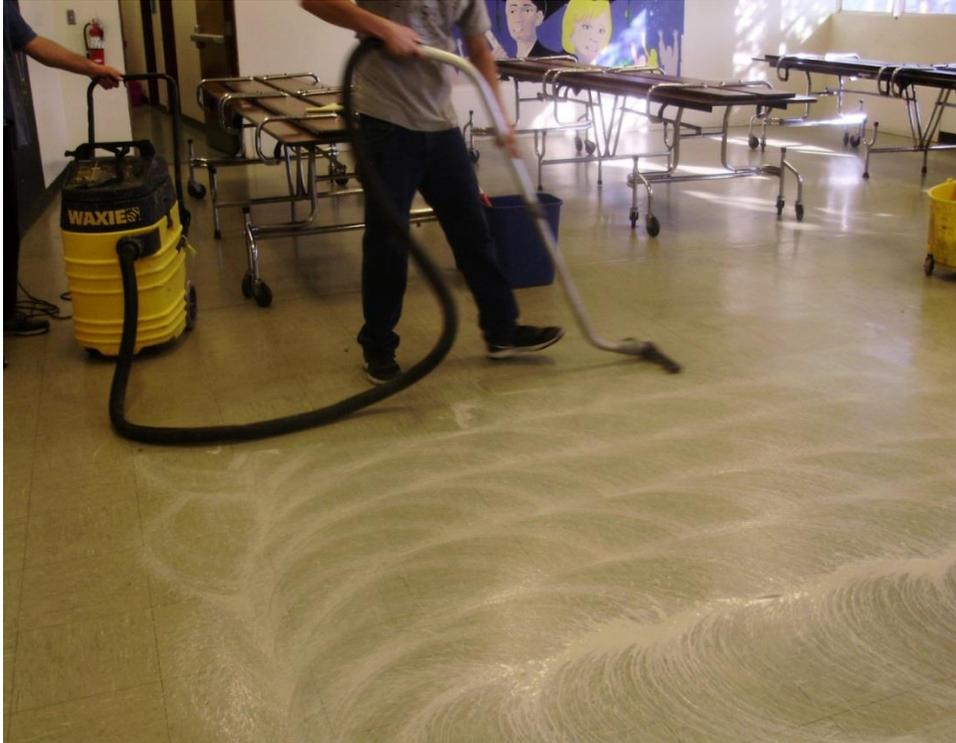
Figure 2-3. Wet Vacuum Handling Residue

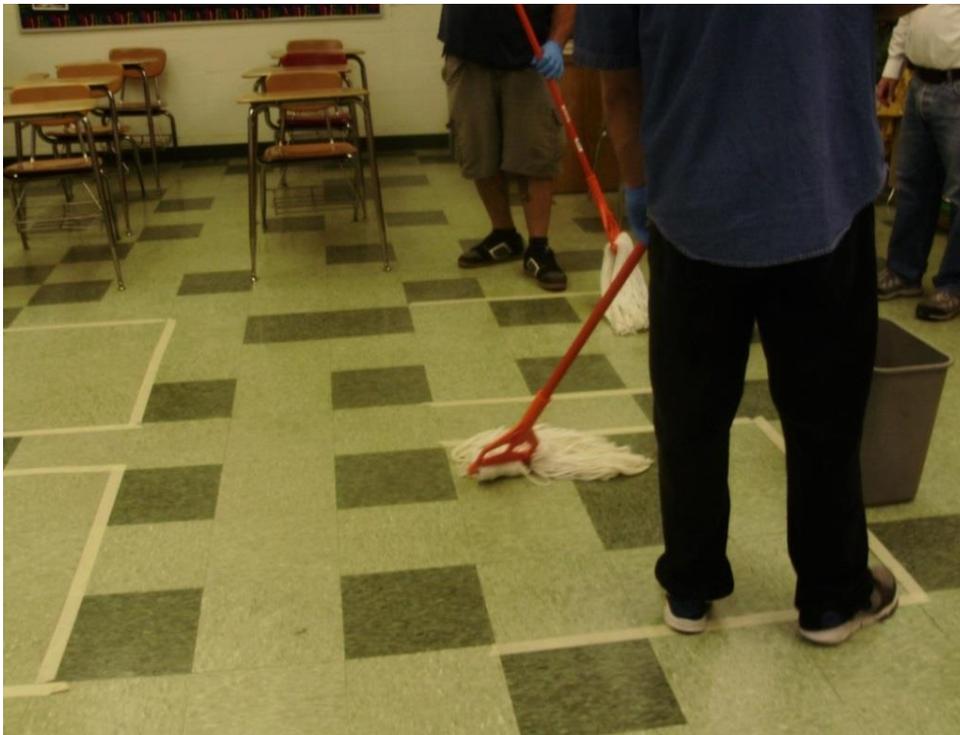
Figure 2-4. Applying Strippers during Tests at Riverside USD

The strippers were tested in a small area in an elevator cove that had a buildup of four or five coats of wax. The strippers were applied and allowed to sit for a time so they could penetrate the coats of wax. Then the floor machine with the rotating Hi-Pro black pad was moved over the area. The wet vacuum was used to suck up the residue and the floors were allowed to dry.

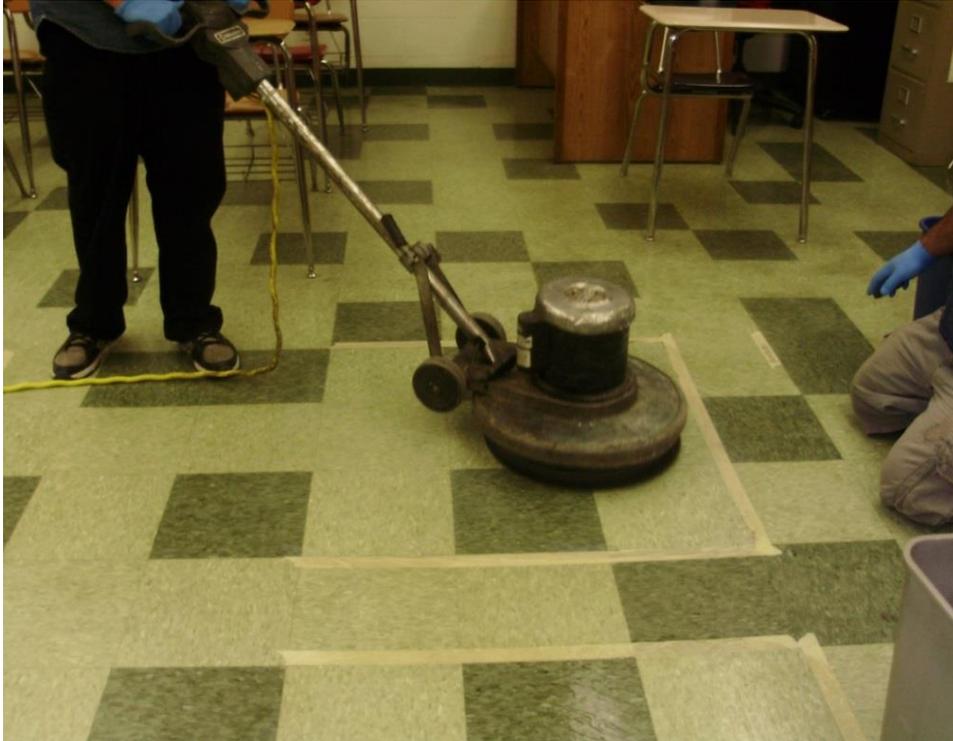
Figure 2-5. Floor Machine Stripping during Tests at Riverside USD

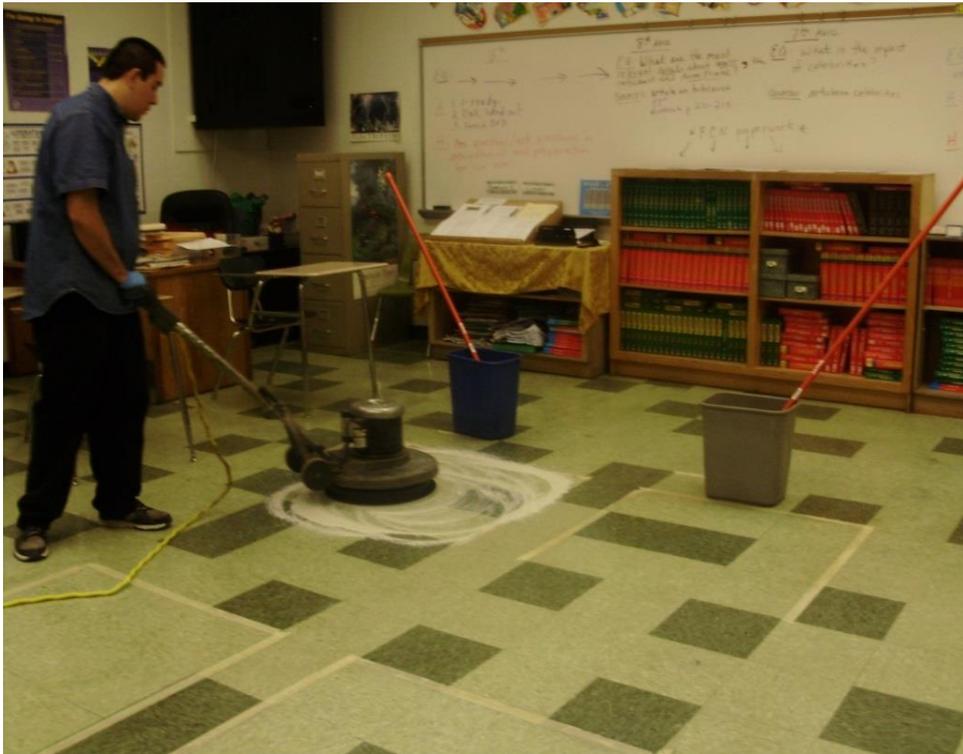
Figure 2-6. Hi-Pro Pad on Floor Machine during Tests at Riverside USD

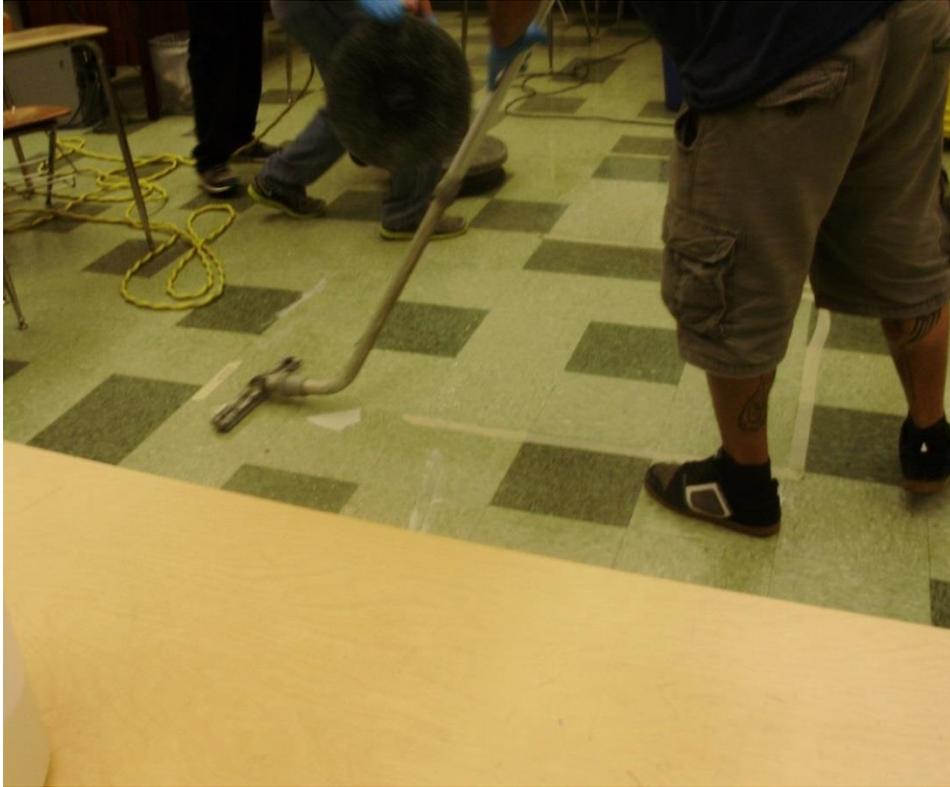
Figure 2-7. Wet Vacuuming Residue during Tests at Riverside USD

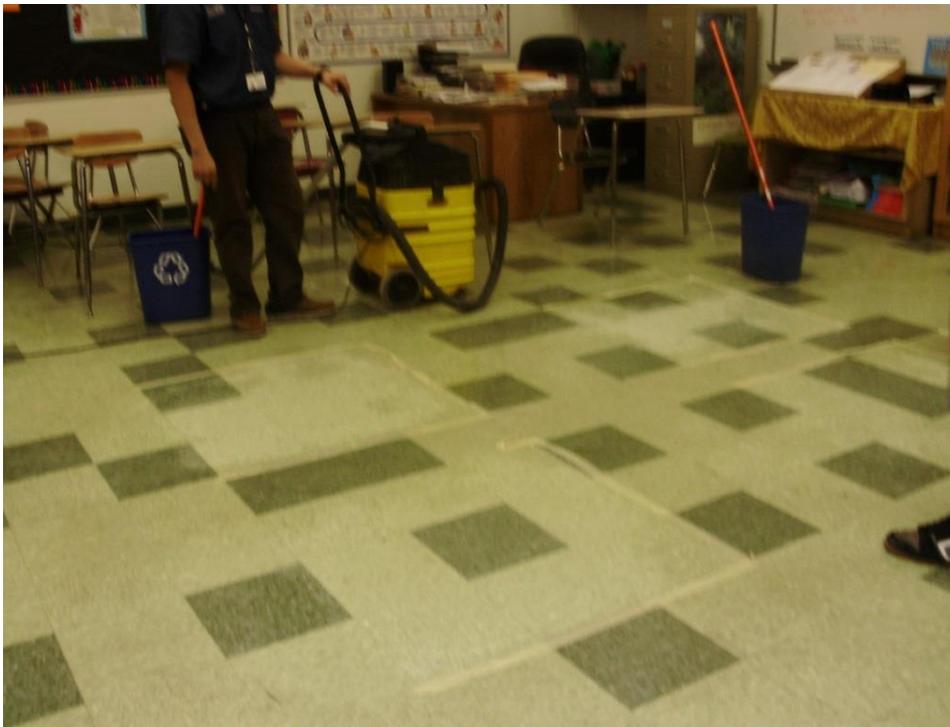
Figure 2-8. Floor after Stripping Tests at Riverside USD

The results of the testing indicated that two of the three strippers performed well, at least as well as the stripper that was used currently. These were the III-14A and the III-14C strippers described above. The maintenance staff preferred one of the strippers, the III-14A stripper, so IRTA and the formulator provided five gallons of the stripper for stripping a hallway that had several coats of wax at a later time.

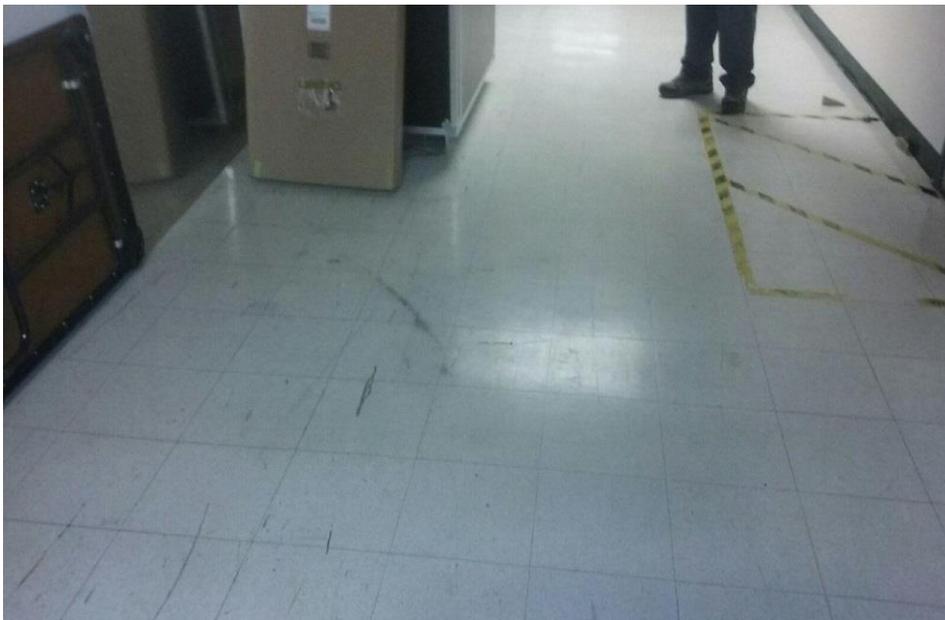
Figure 2-9. Floor before Stripper Application during Testing at SCAQMD Building

The stripper was tested at the SCAQMD building and the maintenance manager indicated the stripper performed well. He said the stripper was able to remove several coats of wax effectively. He noted that he particularly liked the stripper because it created a non-slip surface. This is in notable contrast to other strippers which become very slippery after they are applied. The non-slip characteristic indicates the stripper would be safer for maintenance staff to use. The staff had also given IRTA this feedback during the earlier tests of the three strippers in the alcove. Pictures of the larger scale testing are shown in Figures 2-9 and 2-10. They show the floor before and after the stripper was applied respectively.

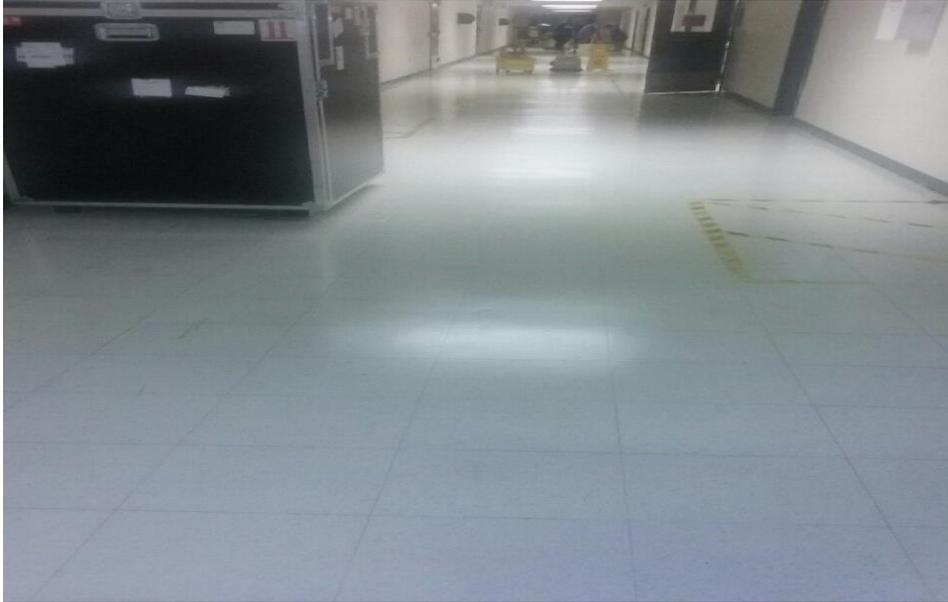
Figure 2-10. Floor after Stripper Application during Testing at SCAQMD Building

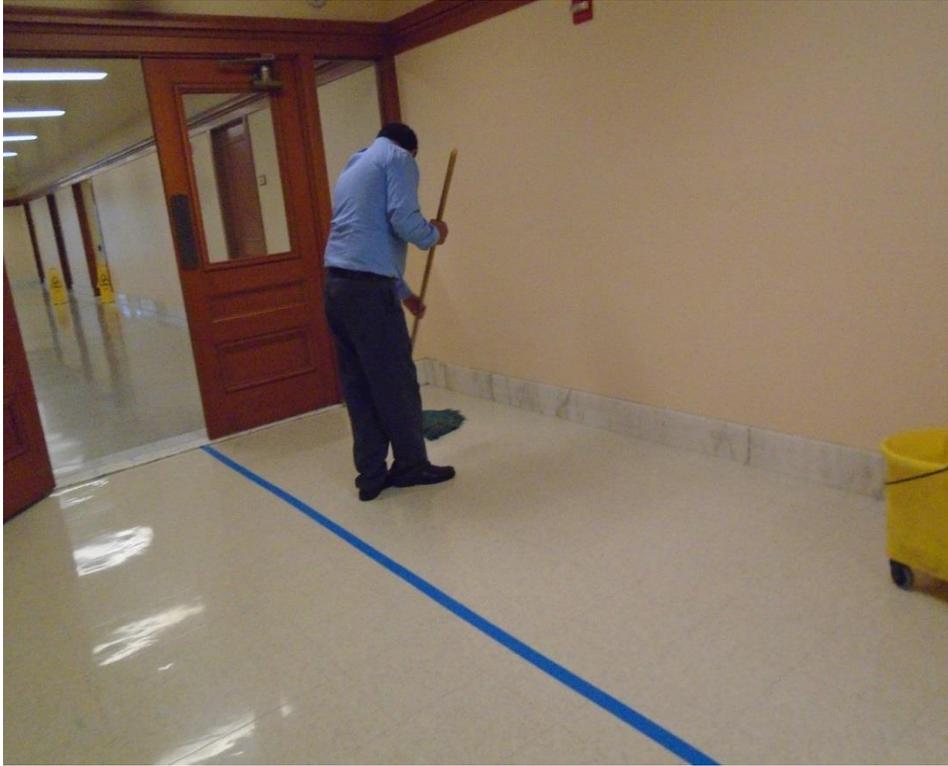
Figure 2-11. Applying Alternative Stripper during Testing at San Francisco City Hall

The maintenance people indicated that there were six or seven coats of wax on the floor which normally would require at least two separate applications of the stripper. The staff first tested the III-14A stripper, the stripper containing solvent. The stripper was applied twice, the floor machine was moved over the floor, the wet vacuum absorbed the residue and the floor was allowed to dry. The stripper had not stripped the wax. The staff started applying the second stripper when it was discovered that the pads that were being used were not Hi-Pro pads. The staff were able to find a Hi-Pro pad and the second stripper, the III-14C, was used with this pad with one application. It was able to strip all of the heavy wax buildup on the floor in one application. All of the III-14A stripper had been used so there was none left to try to strip the wax with the appropriate Hi-Pro pad. Pictures of the staff applying the III-14C stripper and removing the wax are shown in Figures 2-11 through 2-13.

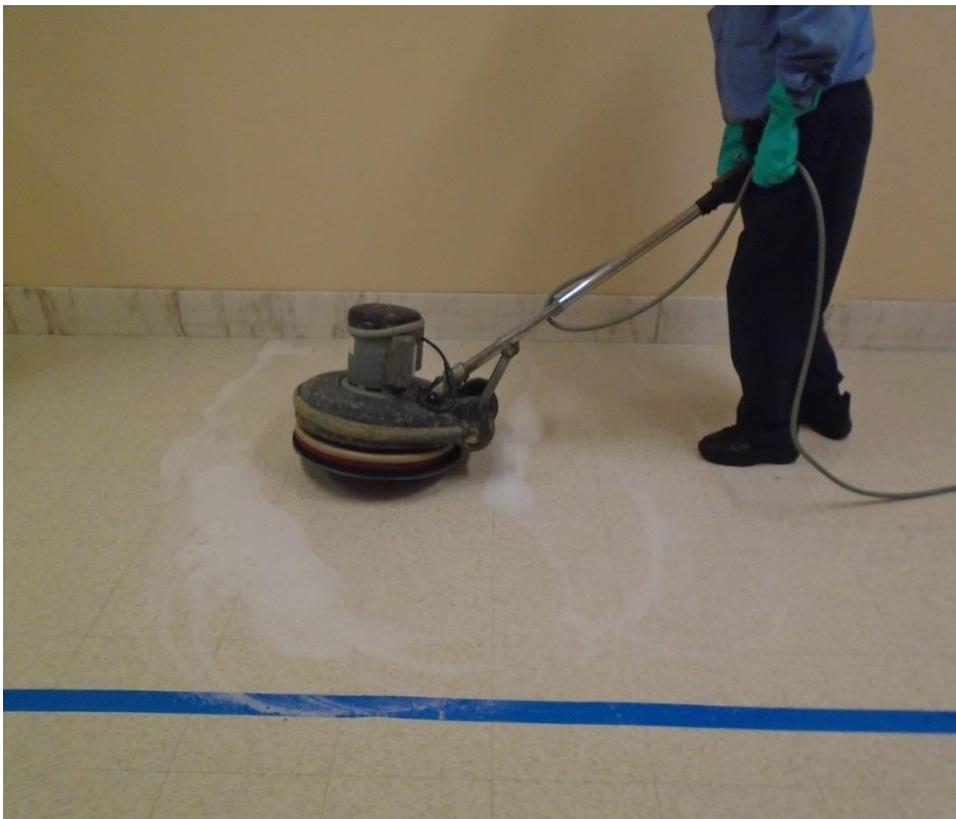
Figure 2-12. Using Floor Machine on Stripper during Testing at San Francisco City Hall

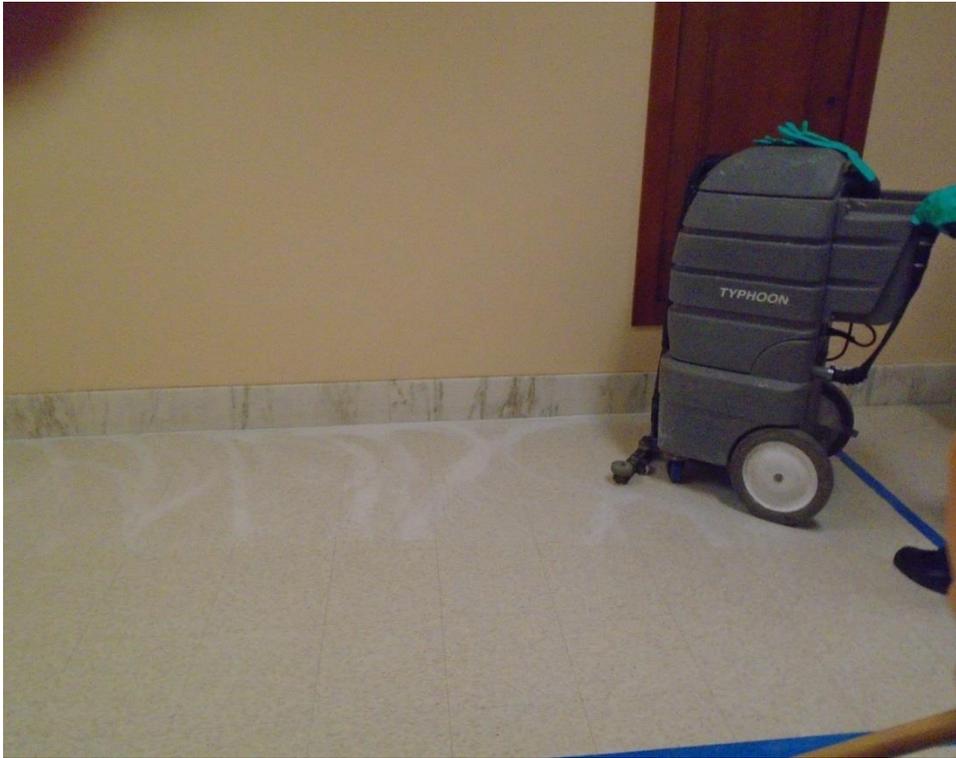
Figure 2-13. Using Wet Vacuuming System during Testing at San Francisco City Hall

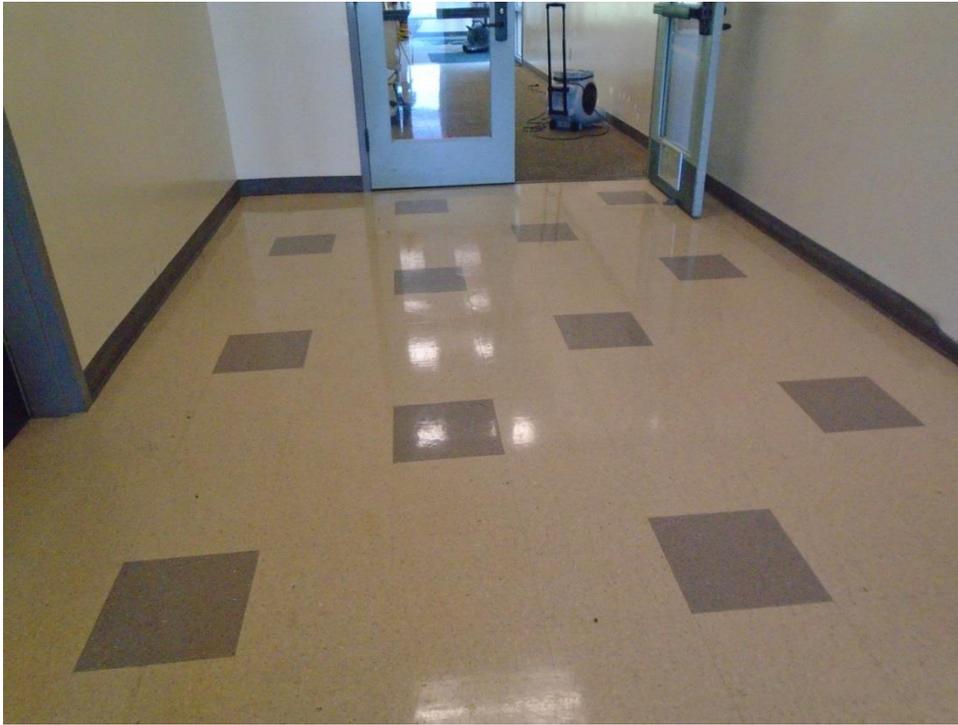
Figure 2-14. Alcove Where Strippers Were Tested at Irvine USD

A picture of the floor in the alcove where the stripping tests were conducted is shown in Figure 2-14. Pictures of the stripping process with the Hi-Pro pad are shown in Figures 2-15 through 2-18.

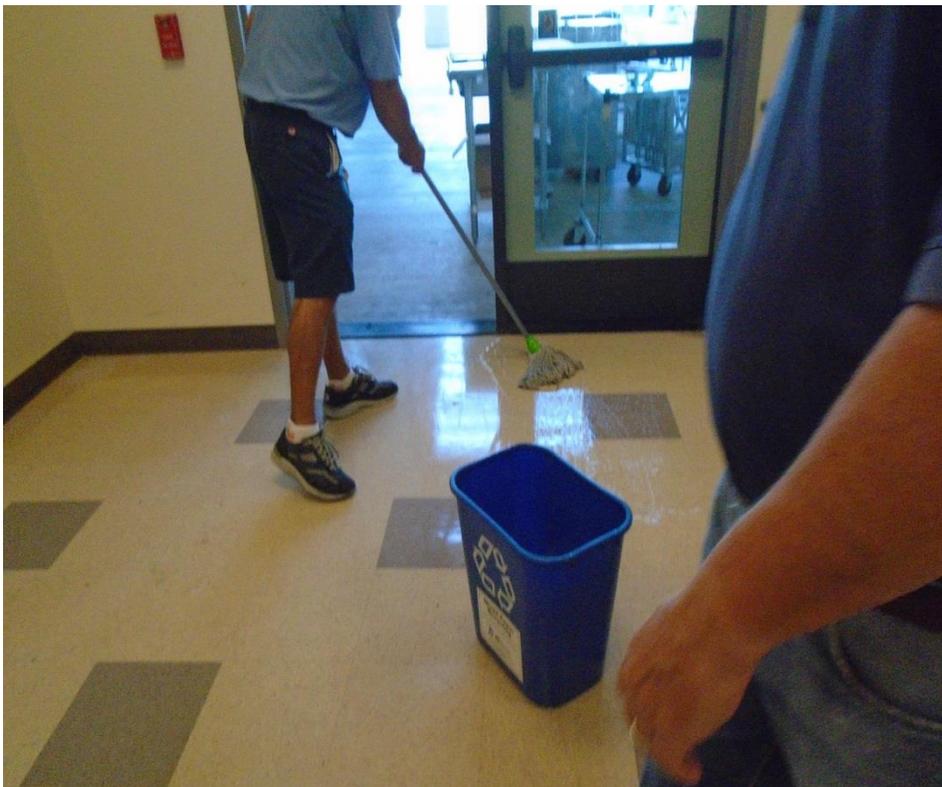
Figure 2-15. Applying Stripper during Testing at Irvine USD

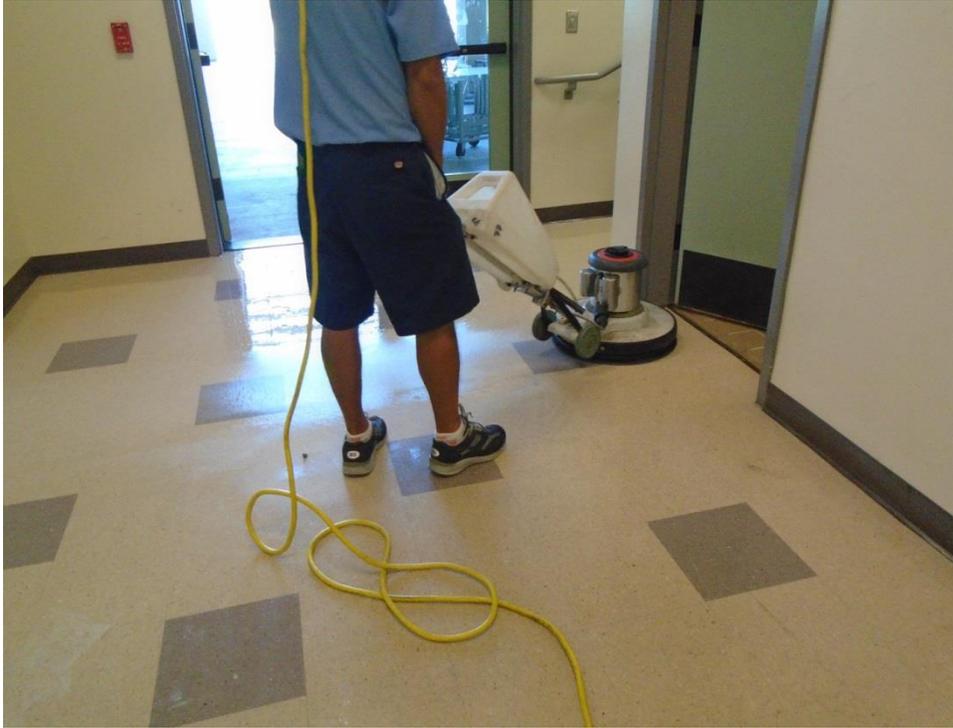
Figure 2-16. Using Floor Machine during Testing at Irvine USD

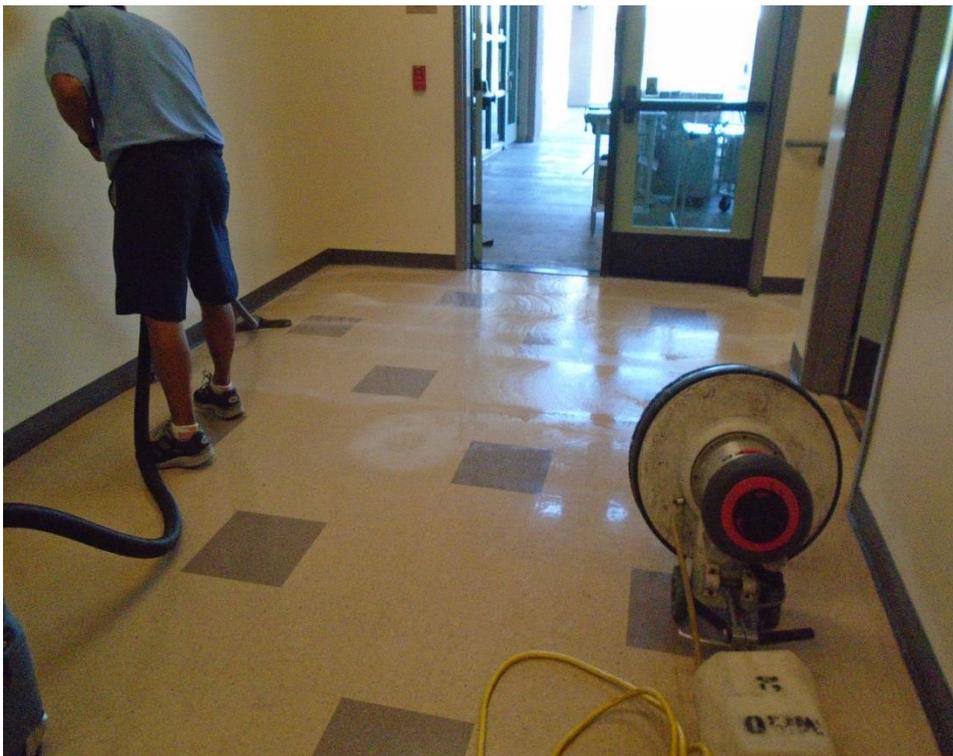
Figure 2-17. Using Wet Vacuum during Testing at Irvine USD

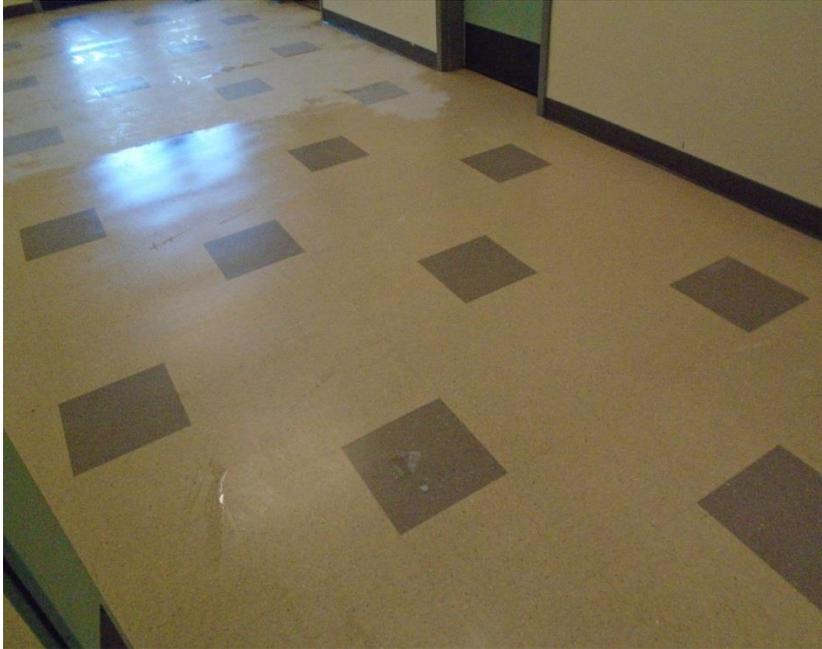
Figure 2-18. Floor after Stripping During Testing at Irvine USD

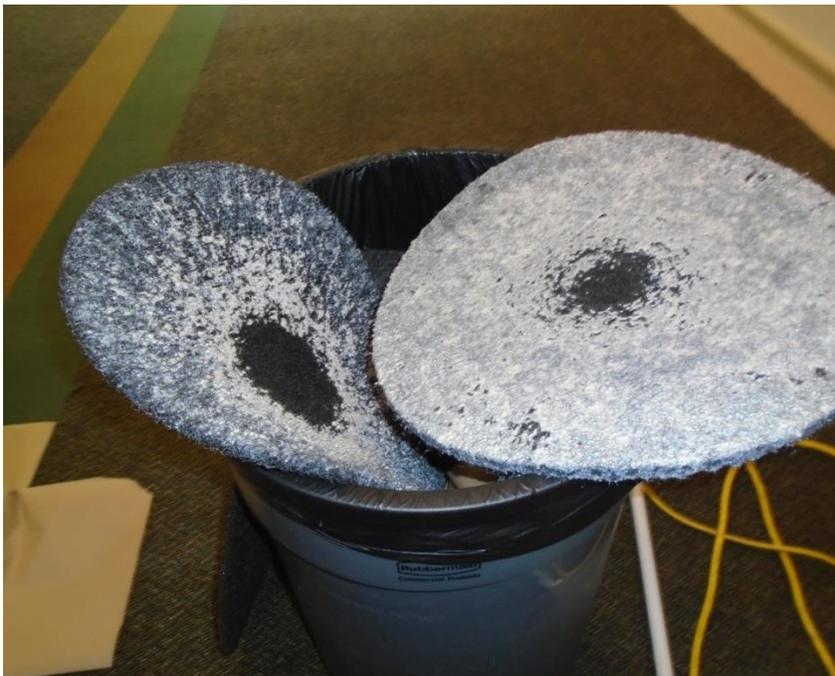
removed and the wax laden pad could not cut through the additional wax; it slipped over the top of the floor. The manager much preferred the Hi-Pro pad. He indicated that the Hi-Pro pad could be washed out and recycled so it could be reused, perhaps several times. This is in contrast to the tighter weave black pads which had to be discarded after one use. A picture of the two pads after the alcove testing is shown in Figure 2-19. The pad on the left is the Hi-Pro pad and the one on the right is the standard black pad.

Figure 2-19. Picture of Hi-Pro and Regular Pad after Stripping at Irvine USD

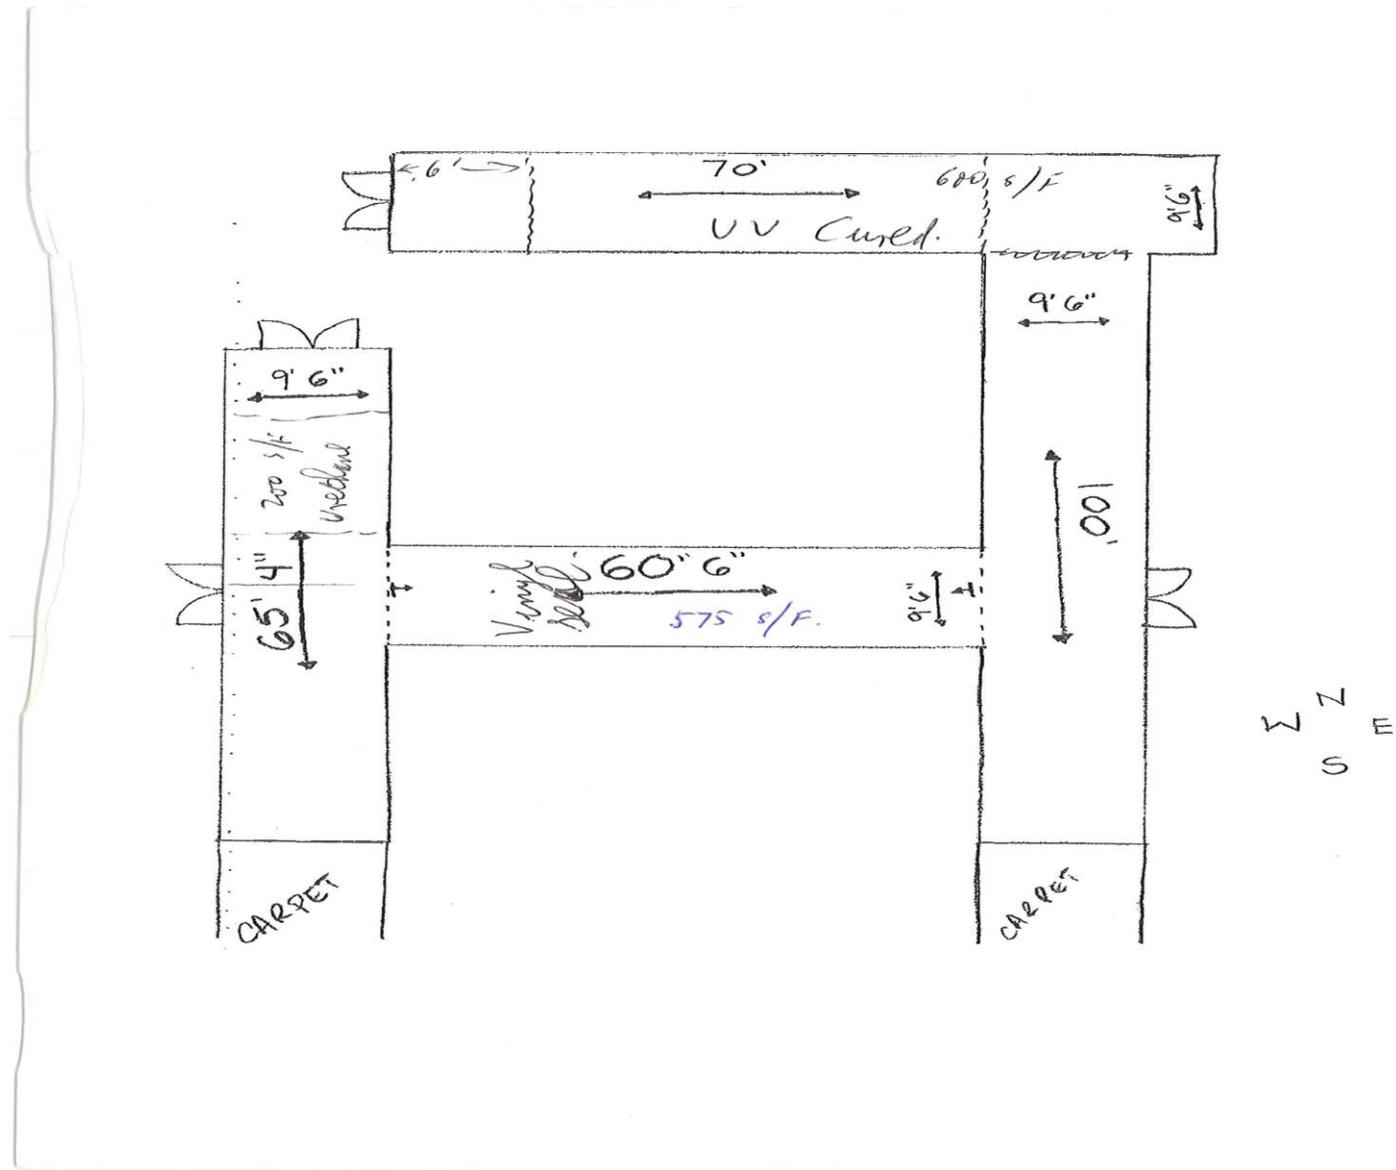
Figure 3-1. Drawing of Hallway System at Riverside School

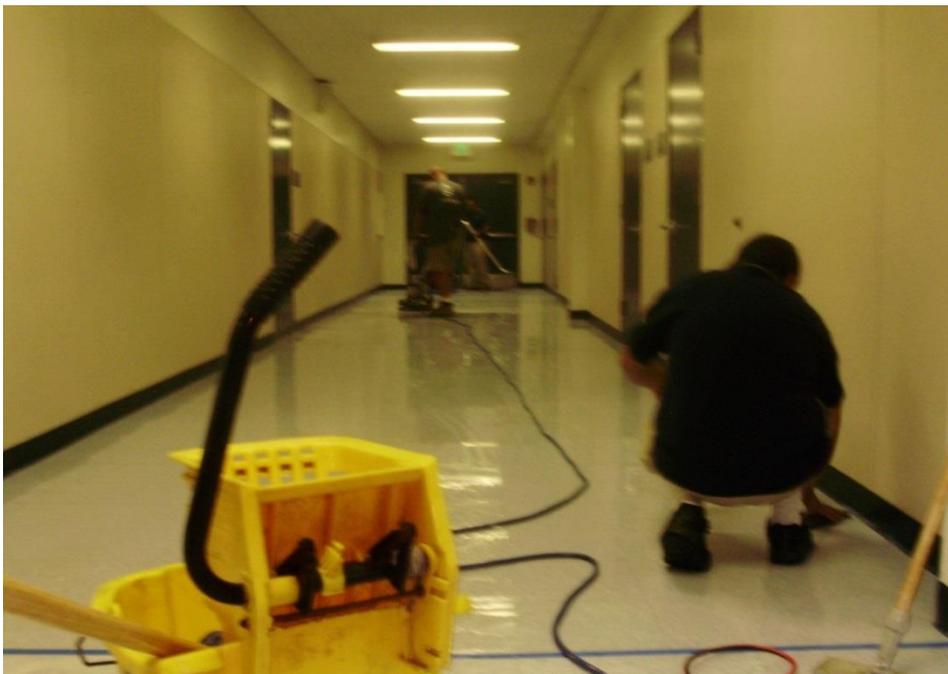
Figure 3-2. Workers Applying Vinyl Seal Coating

A picture of the coating application procedure is shown in Figure 3-2. A picture of the coating after application is shown in Figure 3-3. A picture of the coating in the school hallway just after the school year had ended is shown in Figure 3-4.

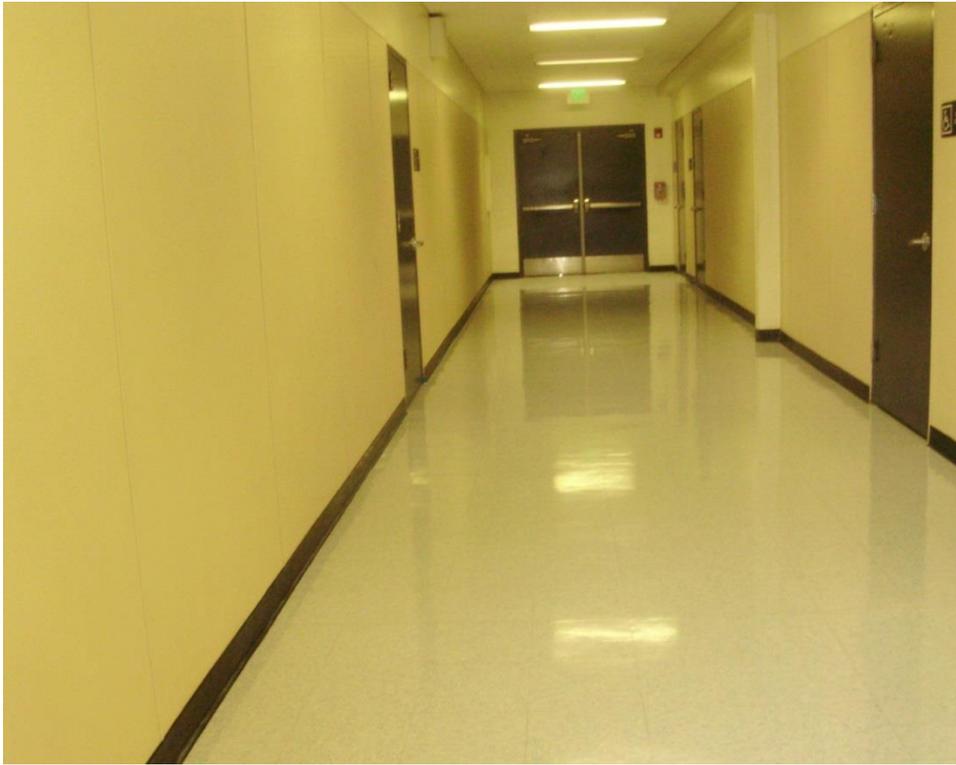
Figure 3-3. Hallway after Application of Vinyl Seal Coating

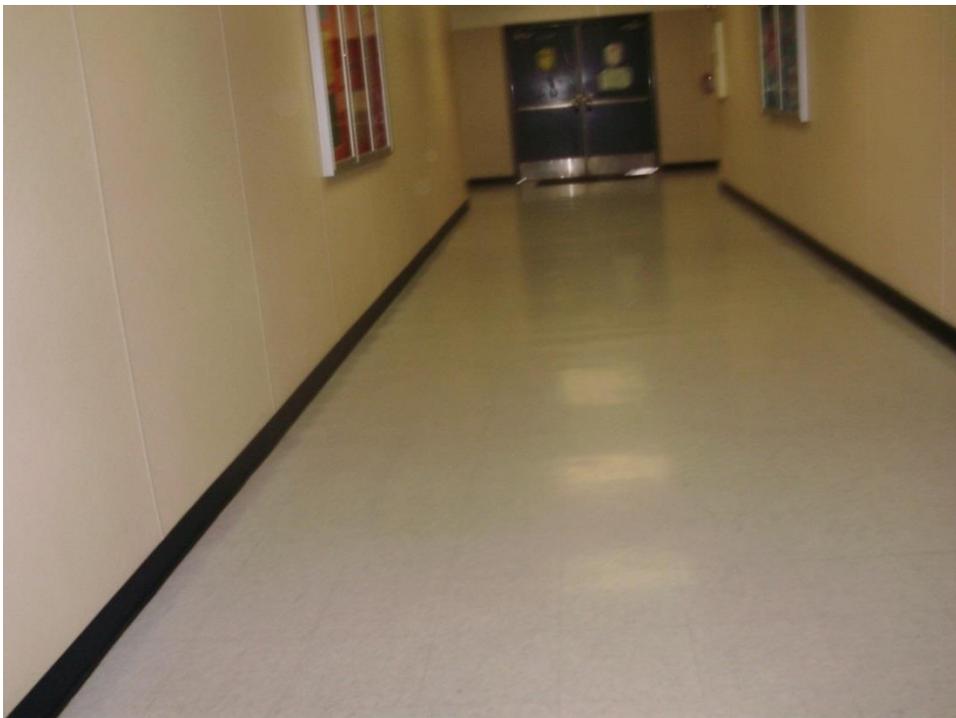
Figure 3-4. Vinyl Seal Coating at End of School Year

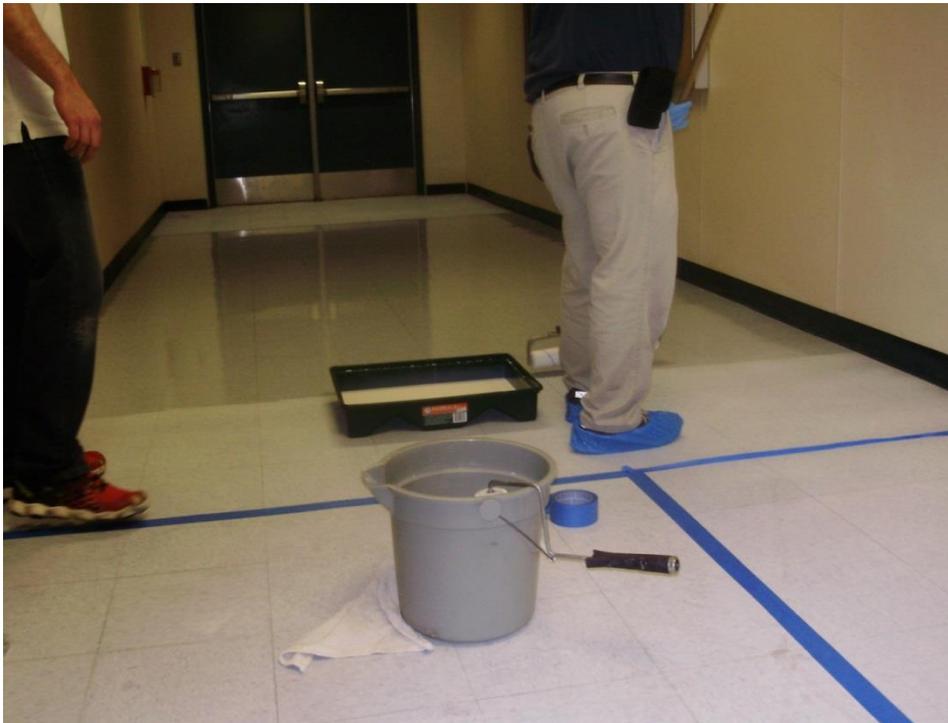
Figure 3-5. Workers Applying Polyurethane Coating

A picture of the workers applying the polyurethane coating is shown in Figure 3-5 and a picture after the coating was applied is shown in Figure 3-6. Note that this coating, like other polyurethane coatings, has an appearance of orange peel. This follows from the fact that the VCT underneath does not have a uniform surface appearance. Figure 3-7 shows a picture of the coating when the school year had ended.

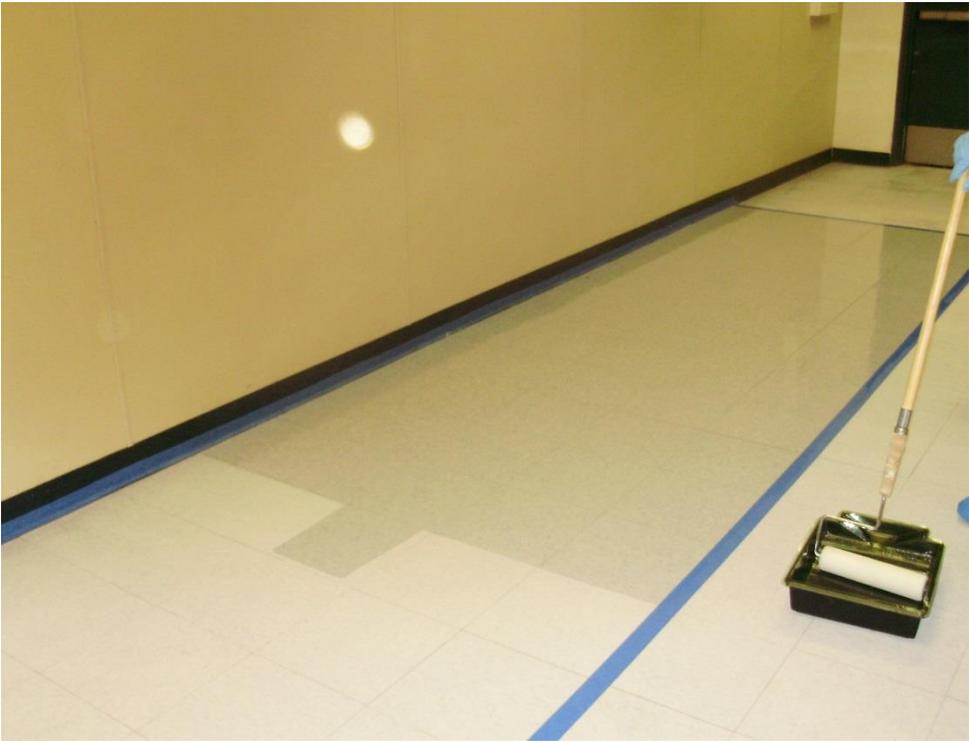
Figure 3-8. Workers Applying UV Coating

A picture of the UV coating application is shown in Figure 3-8. The floor machine with the UV lights on the bottom is shown in Figure 3-9. Figure 3-10 shows the coating after the application and Figure 3-11 shows the coating after the school year had ended.

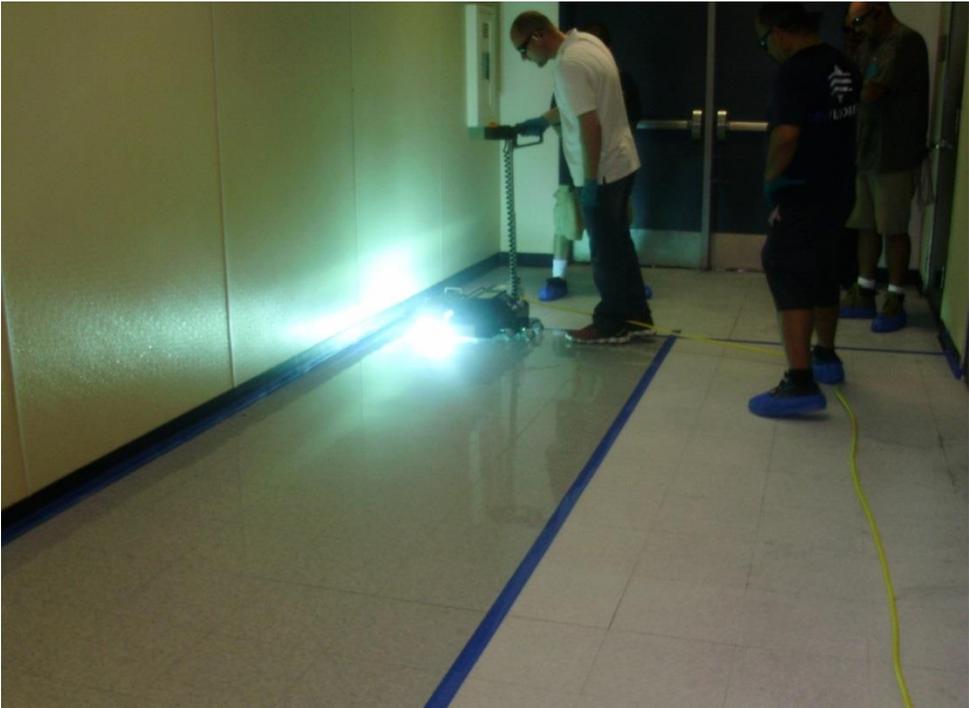
Figure 3-9. Floor Machine with UV Lights

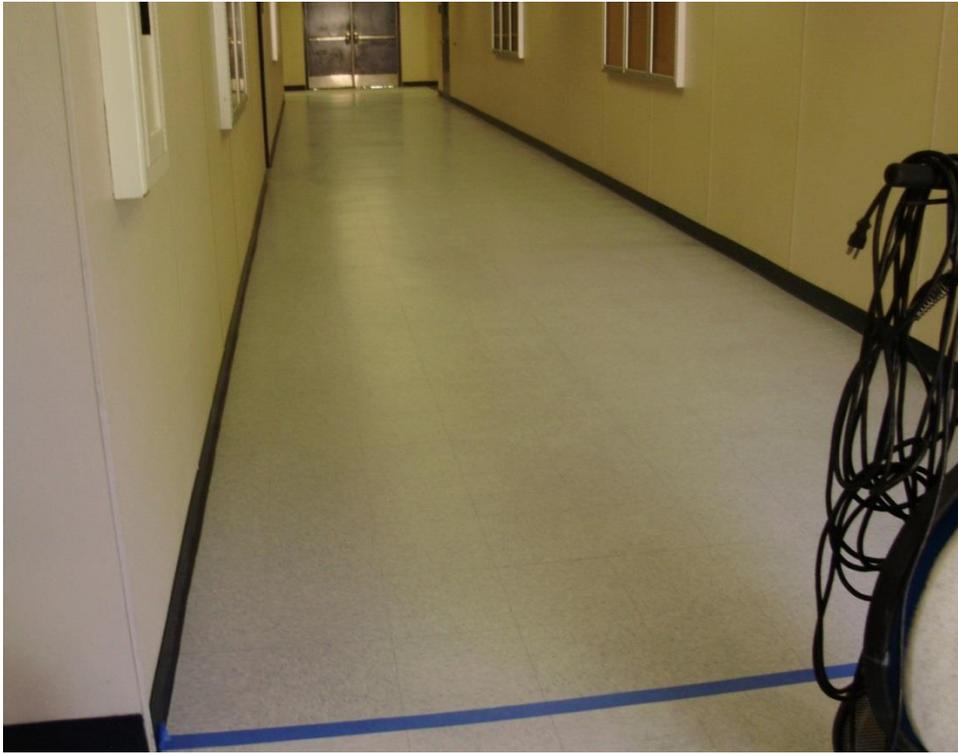
Figure 3-10. Hallway after Application of UV Coating

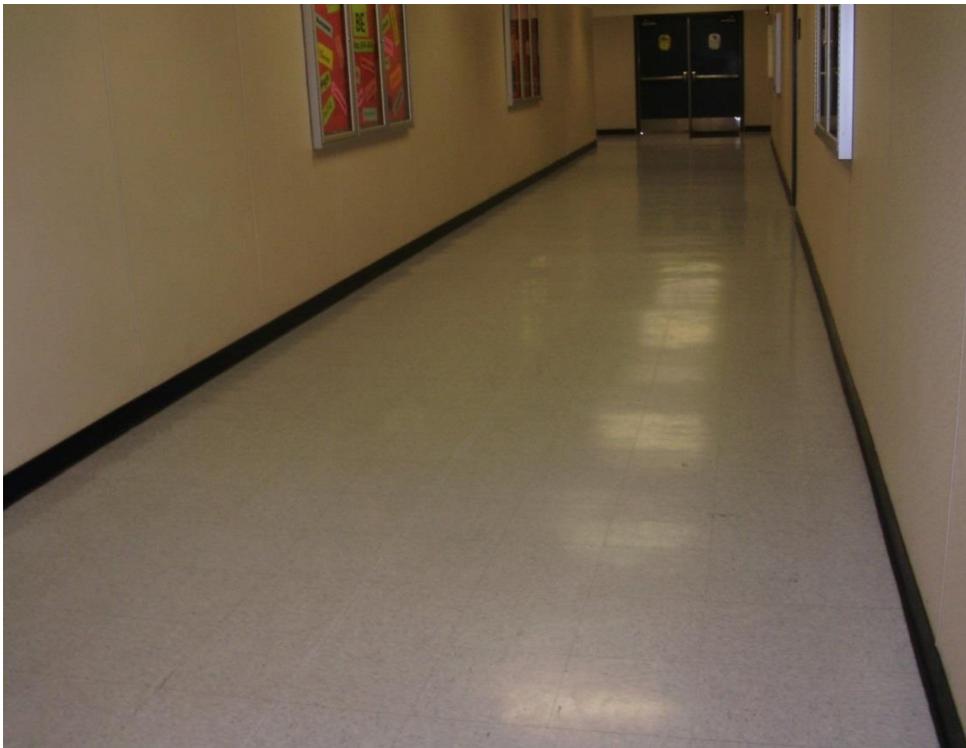
Figure 3-11. UV Coating at End of School Year
