## **Safer Alternatives to Current Floor Wax Strippers for Schools and Public Buildings**

Katy Wolf

Institute for Research and Technical Assistance

October 2015

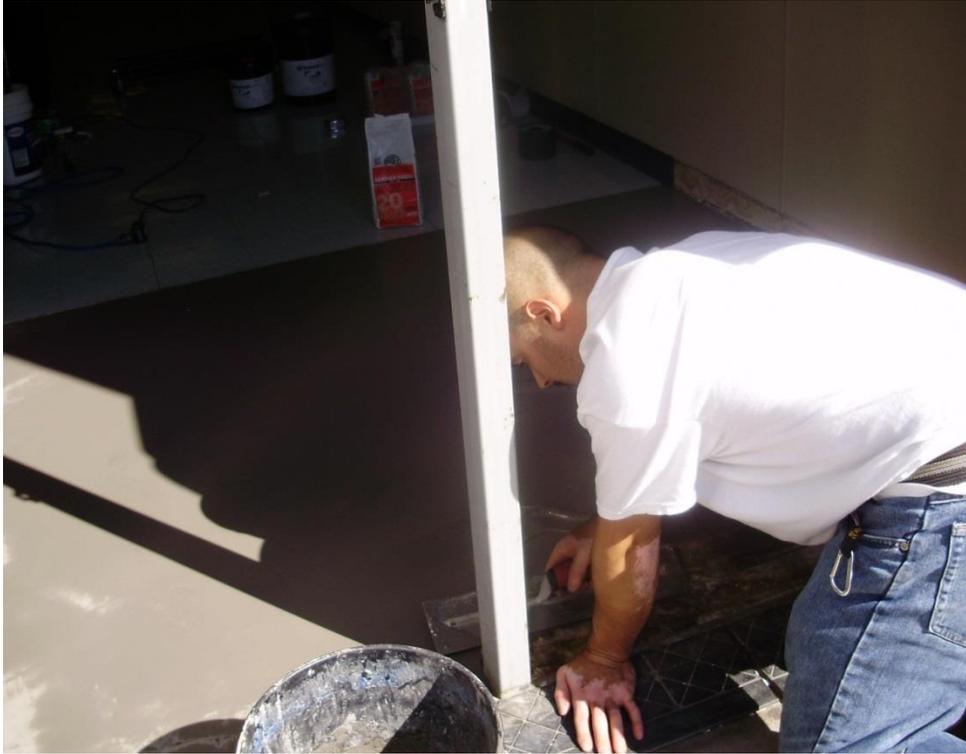
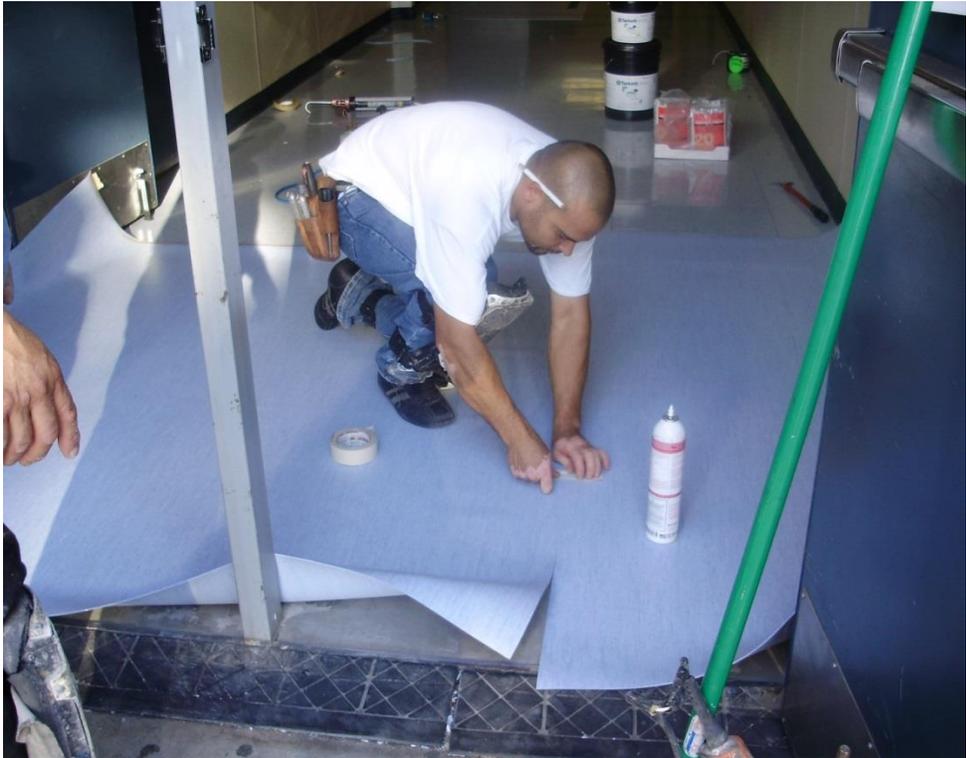
Figure 4-1. Workers Installing Optima IQ Flooring.

Figure 4-2. Another View of Workers Installing Optima IQ Flooring

At the end of the monthly inspections of the coatings and alternative flooring, the Optima IQ had several scratches and the Centiva Contour flooring had one scratch. The Optima IQ was positioned at one of the busiest entrances and the Centiva Contour flooring was in the main hallway in another school where trucks made routine deliveries. All of the other flooring was in good shape. The staff at the school where the Centiva Contour flooring was installed in the hallway liked the flooring and wanted to have it installed throughout the school. The staff at the school where the Mondo was installed in a multipurpose room liked the flooring and thought it looked very good.

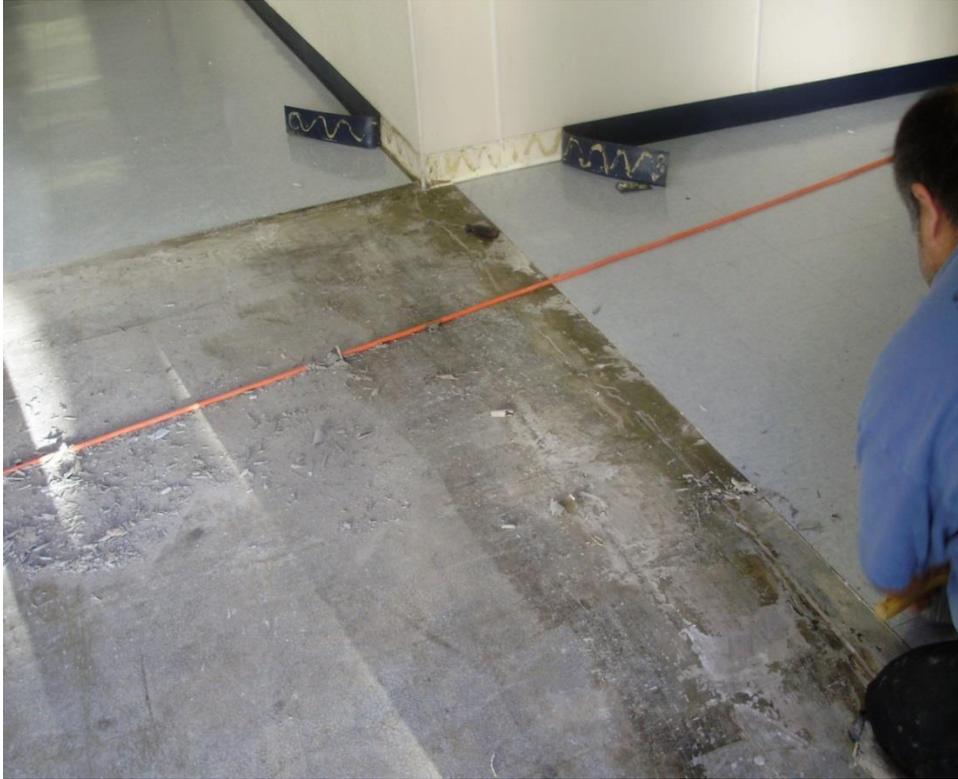
Figure 4-3. Workers Installing EcoPure Flooring

Partway through the school year, the EcoPure flooring, which was located at one of the entranceways, was lifting up from the concrete below around the perimeter. The installer replaced the VCT surrounding it and injected additional adhesive between the concrete and the Eco Pure around the perimeter.

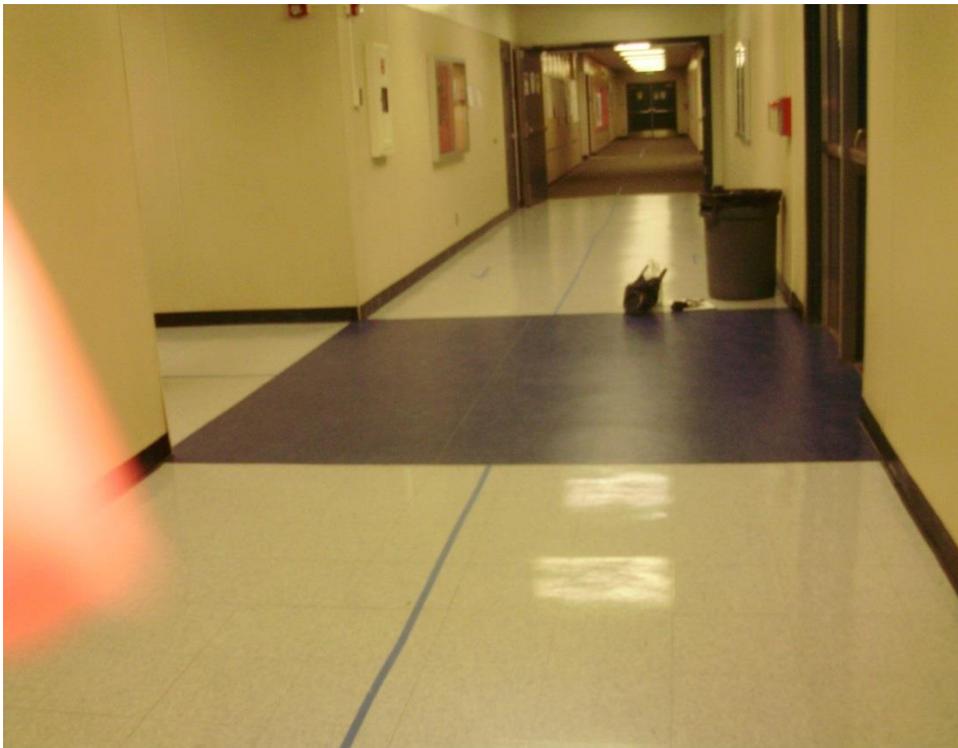
Figure 4-4. EcoPure Flooring after Installation

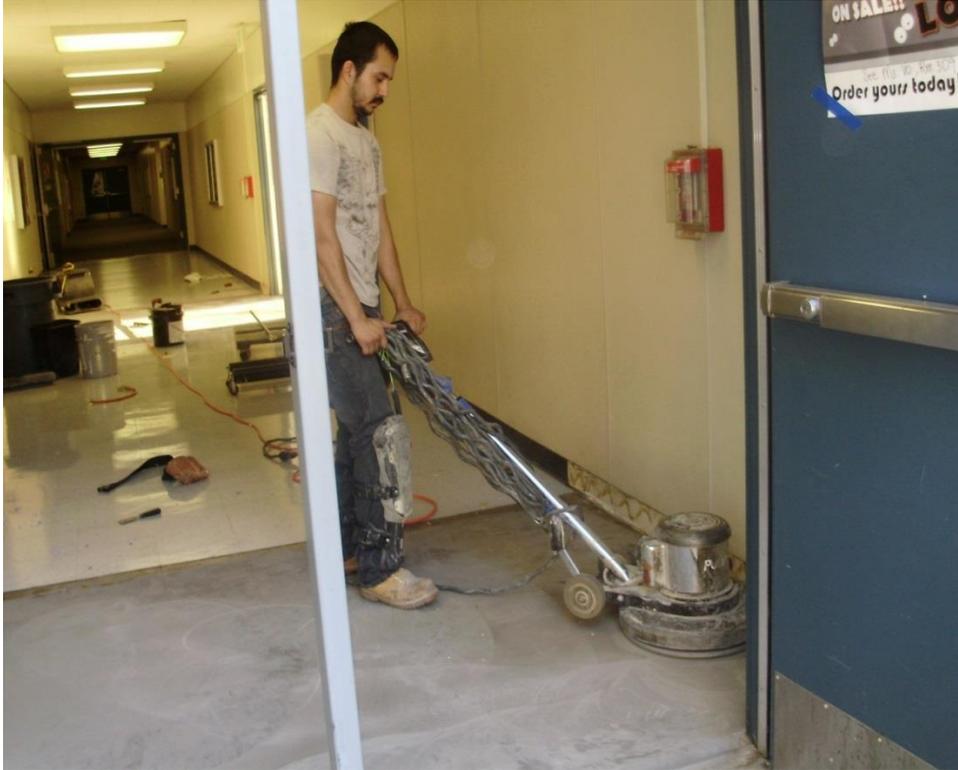
Figure 4-5. Workers Installing Omni Sports Flooring

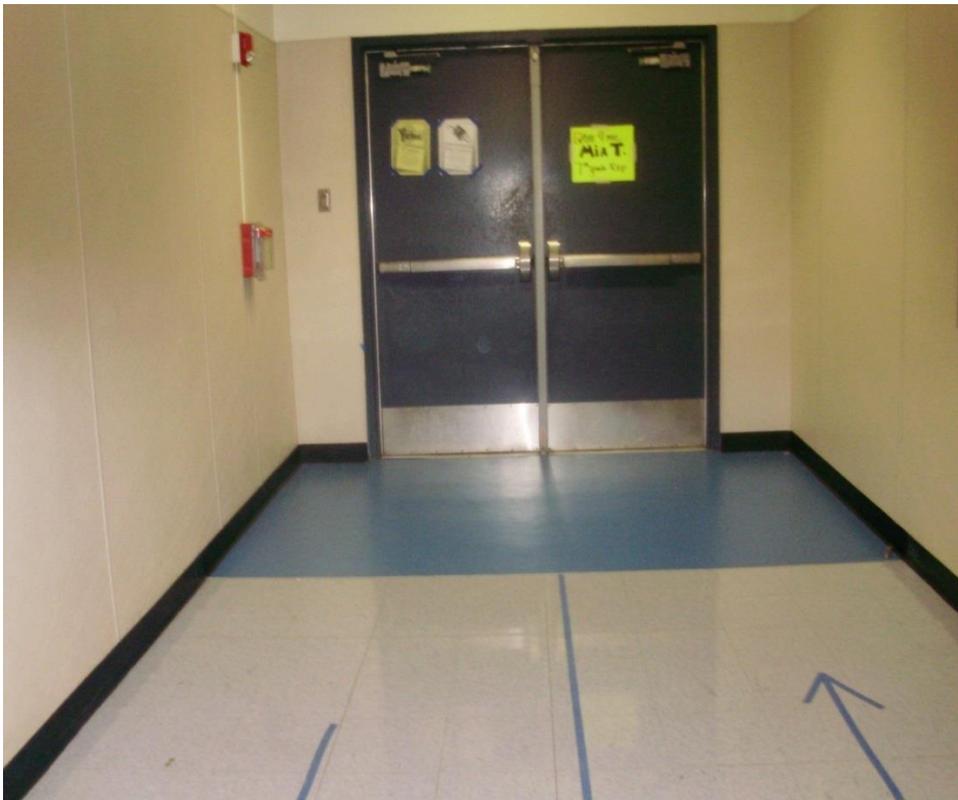
Figure 4-6. Omni Sports Flooring after Installation

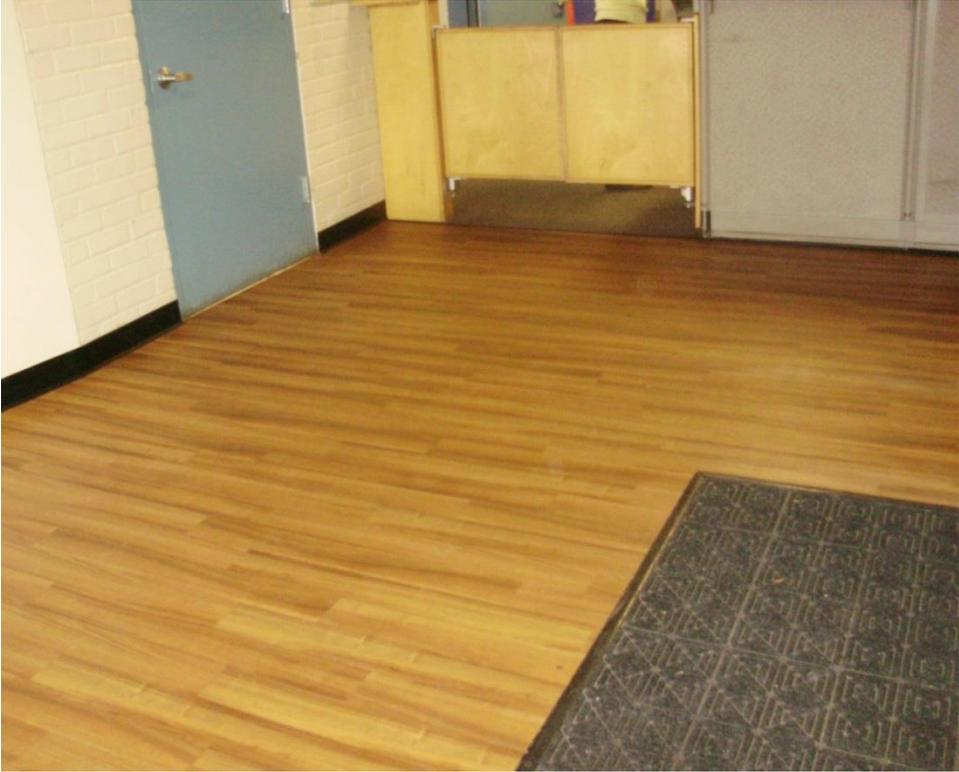
Figure 4-7. Centiva Countour Flooring after Installation

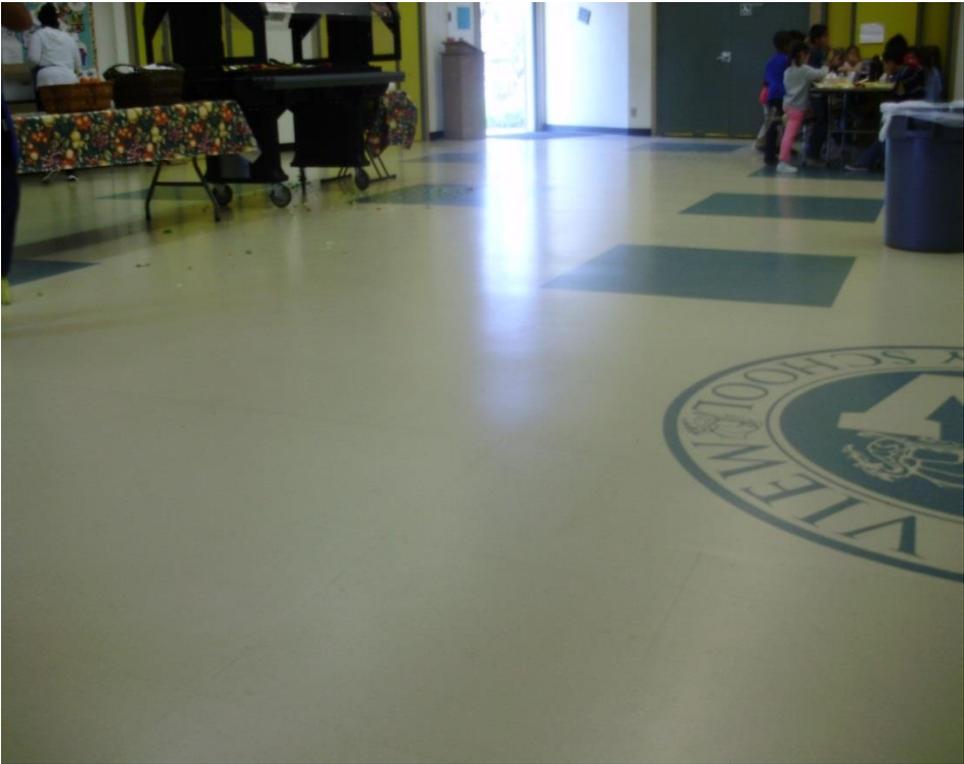
Figure 4-8. Mondo Flooring after Installation

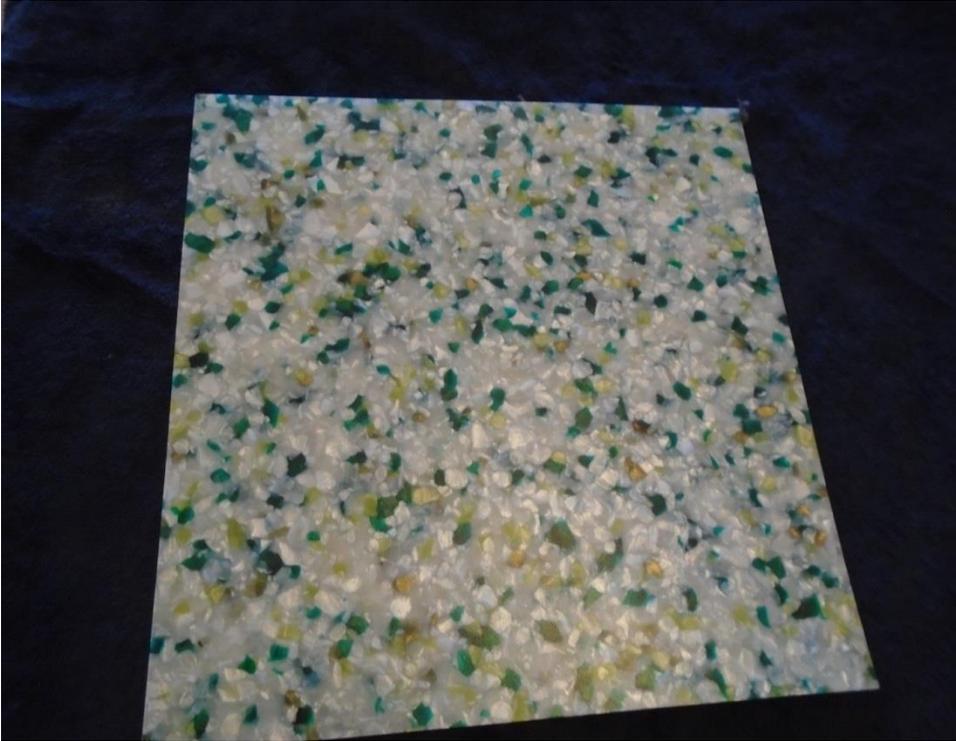
Figure 4-9. Centiva Mineral Chip Flooring Evaluated in Cost Analysis
