*Project, NP00946501-4:*  
**Safer Alternatives to Copper Antifouling Paints  
for Marine Vessels**  
**FINAL REPORT**

January 2011

**Unified Port  
of San Diego**

**IRTA**

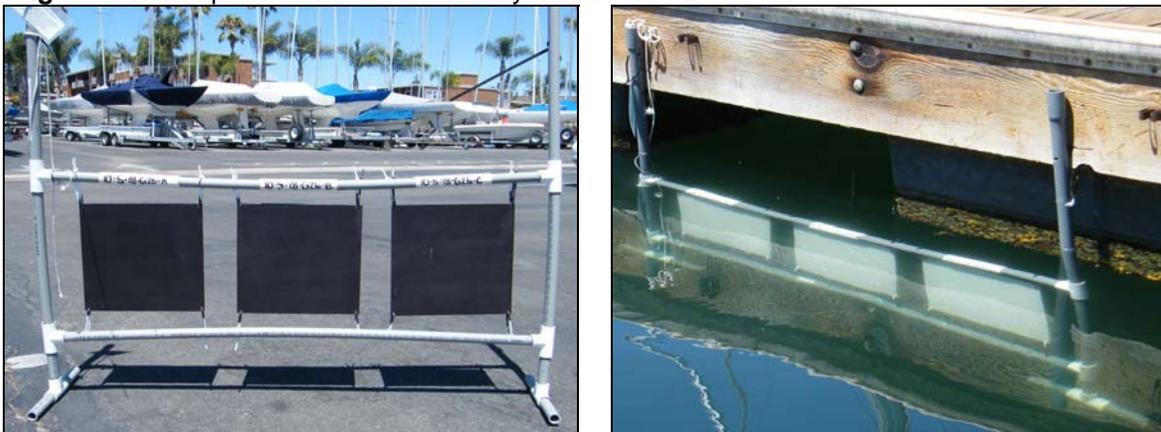
**Figure 3-1.** Complete Test Panel Assembly Installed On Dock

PVC frames were constructed to stabilize the panels so that a vertical position could be maintained at all times in the water. The PVC frames were modeled after test frames designed by Dr. Geoff Swain (Florida Institute of Technology, Center for Corrosion and Biofouling Control). An example of the type of frame used is shown in Figure 3-1. Each PVC frame held three fiberglass panels comprising a panel assembly. Panels were attached to the PVC frame with cable tie wraps on each corner. The PVC frames were then attached to floating docks and submerged so that the top of each panel was 12 inches under the surface of the water. PVC poles attached to the PVC frame connected the frame to the floating dock.

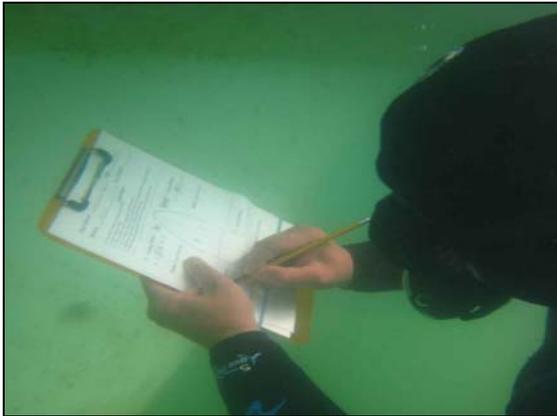
**Figure 6-2.** Documenting hull conditions

During each pre-cleaning assessment, the hull cleaner determined an overall pre-cleaning coating condition rating for the entire hull and also noted any blemishes or scratches on boats surface by quadrant (Figure 6-2). Table 4-5 identifies the rating scale for evaluating the coating condition which was evaluated on a 0-5 scale. Ratings of 1-3 represented a surface appearance associated with normal physical wear due to underwater cleaning action or hydrodynamic effects. Ratings 4 and 5 indicated either excessive cleaning actions or blistering due to internal failure of the paint system. Such blisters are not the result of cleaning but may not be noticed until after a cleaning event. The hull cleaner recorded a coating condition rating for the boat on the diver field form and provided additional observations or comments, such as noting the location or type of damage observed on the boat hull, if any was observed.

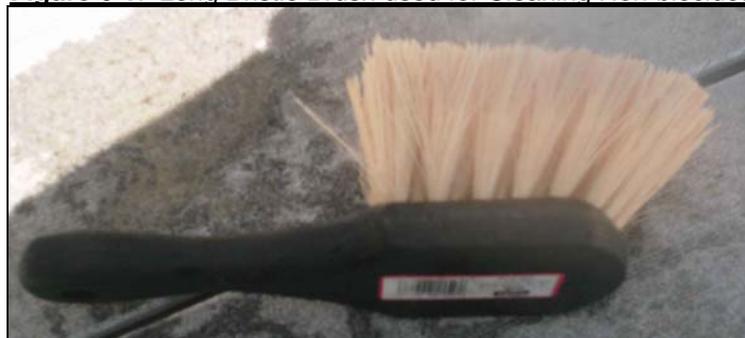
**Figure 6-1.** Long Bristle Brush used for Cleaning Non-biocides

Cleaning: The red Hempasil X3 (87500) variation performed as well as copper hull paint standards in terms of cleaning. Soft fouling accumulated quickly and required regular cleaning. The cleaning effort for this boat was minimal, and required light pressure to remove the loosely attached fouling. Partial cleaning was performed most often, primarily along the waterline with a microfiber cloth or terry cloth. The Project Team consulted with the coating manufacturer about incorporating the use of a different type of cleaning tool to remove heavier algae growth that appeared along the starboard side during one of the inspections. The Project Team included the use of a long bristle brush to remove the slime/algae (Figure 6-1). This tool was identified for use for a similar fouling release non-biocide coating, Intersleek 900, and was effective in removing algae with no damage to the coating. In general, the results for red Hempasil X3 (87500) variation indicated the test coating was effective when cleaned with a soft cleaning tool such as a terry cloth towel on a regular frequency.

The Project Team noted areas during a couple of the inspections in which algae growth on the starboard side of the 30' sailboat required higher effort with the terry cloth or carpet. The Project Team consulted with the coating manufacturer about incorporating the use of a different type of cleaning tool to remove heavier algae growth that appeared along the starboard side. As a result, the Project Team included the use of a long bristle hand brush (Figure 6-1) and microfiber hand mitts to remove the slime/algae. Both tools were identified for use in International Paint's Intersleek 900 application manual and appeared to be effective.

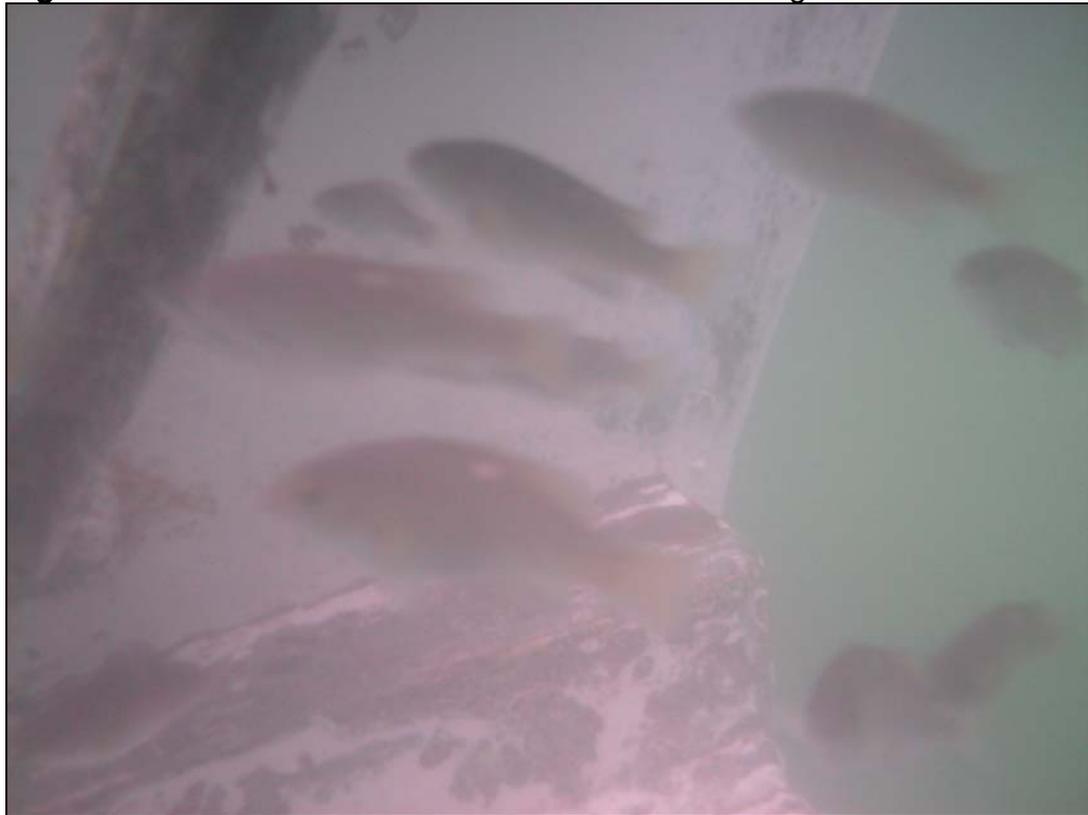
**Figure 6-2.** Surf Perch near Intersleek 900 Test Coating

A unique situation arose with Intersleek 900 during the study. Small imprints were observed on the bottom of both boats (Quadrants I-IV). Upon closer examination the Project Team concluded the imprints were caused by fish, such as surfperch. In fact, during one inspection of the 30'sail boat, the hull cleaner observed surfperch actively nipping at the boat hull (Figure 6-2). At the conclusion of the study, there did not appear to be any structural side effects of the feeding of the surfperch. There is concern that this feeding behavior may potentially lead to coating damage, and the potential effect on long term performance is unknown.
